Irondequoit Bay Slope Vegetation Management Plan

**Town of Irondequoit
1280 Titus Avenue,
Rochester, NY 14617**

Final Report

May 2008

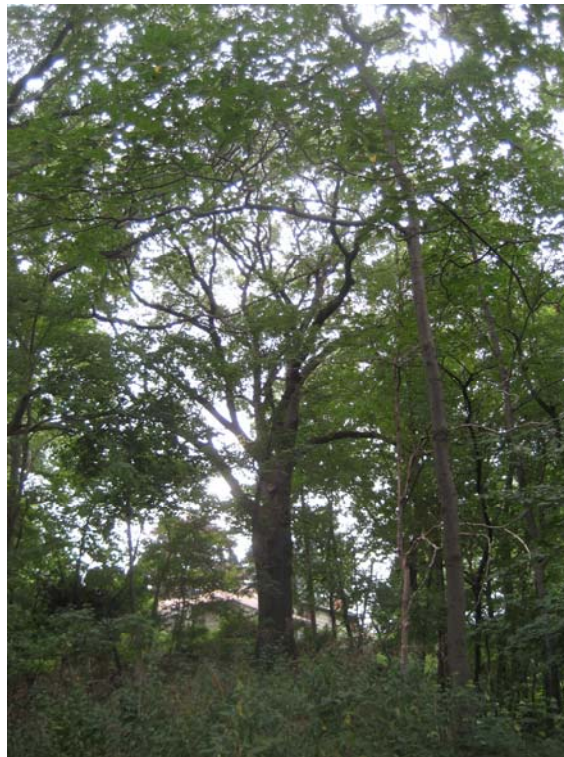
Photo 1. A native stand with large mature oak trees and plentiful understory vegetation.

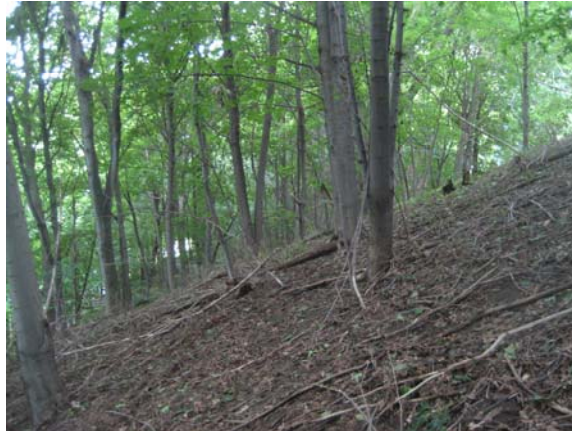
The lack of shrubs and ground cover in non-native stands is likely due to the intense shading associated with Norway maple and dense stands formed by ailanthus and Norway maple. This absence of shrubs and ground cover may

**Photo 2. An intermediate stand of Norway maple.
Note that there is no shrub or groundcover
layer due to the dense shading.**

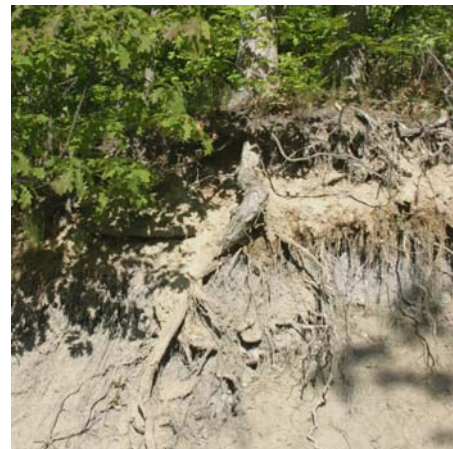
**Photo 3. An exposed tap root of a
white oak on a washed out bank.**

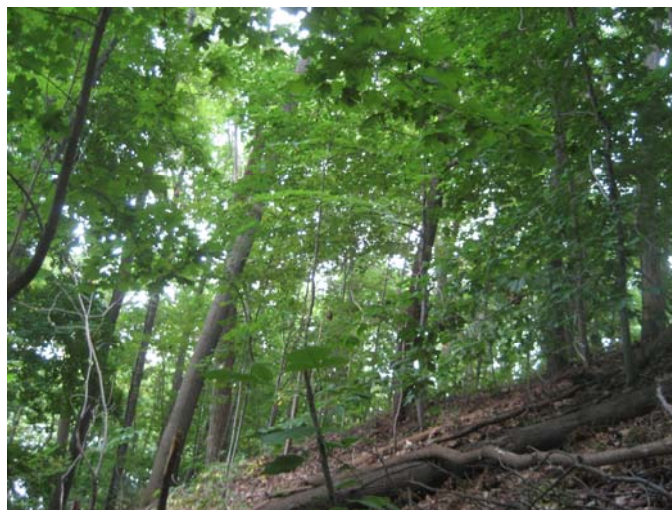
One of the most significant findings of the survey is that that over 40% of the stands were classified as mixed native and non-native invasive species. These stands would likely be converted to non-native species if disturbance occurs because of the high reproductive potential of Norway maple and ailanthus and their ability to rapidly produce dense shade and exclude other vegetation. However, elimination of non-native invasive species from these stands seems impractical. Therefore, avoiding disturbances to the degree possible seems to be the most reasonable management option where these mixed stands are present.

**Photo 4. Mixed stand of native and non-native plant species.
Disturbance of these stands will likely convert
them to mostly non-native species.**

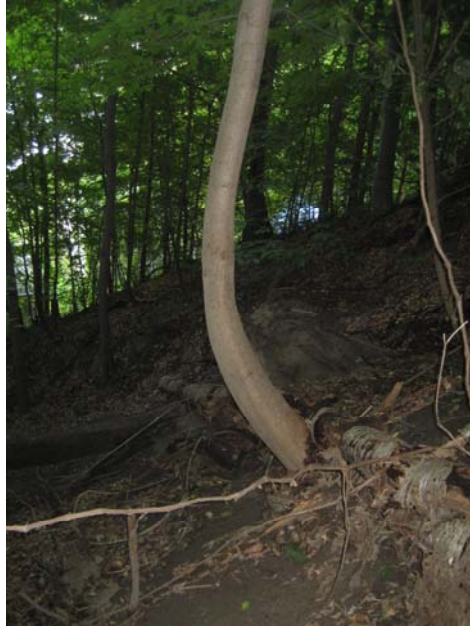
Photo 5. Invasive Norway maple stand with virtually no understory vegetation. The slope is moving downward as indicated by the curve in the tree trunk. The slope moves, the tree leans and then self-corrects to grow to the light source in the top of the canopy.

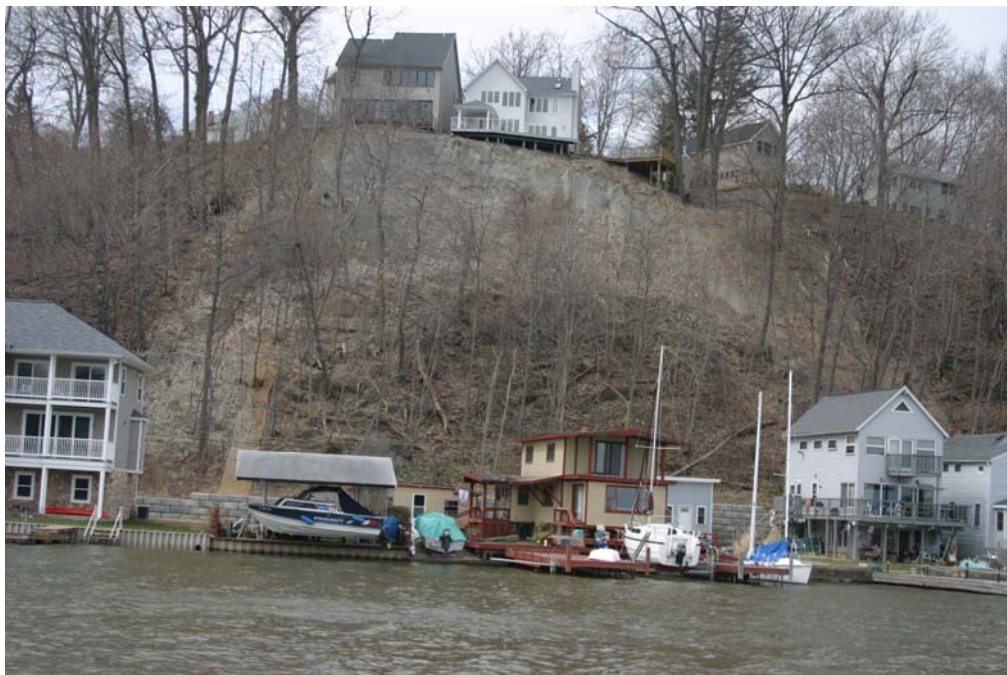
Photo 6. The German Village slide of 2004 threatened homes on the top and bottom of the slope. Contributing causes of the failure included the predominant tree species on the slope was non-native Norway maple, clearing of trees on the slope and the discharging of rain gutters on the slope from homes at the top of the slope.

The stand type is invasive, young in age and vegetation cover is approximately 55%. This is the German Village slump failure. Slopes are approximately 30-40%. The over story trees are red oak at the top of the slope and comprise approximately 5% of the trees. The intermediate and sapling trees are Norway maple, ailanthus and some boxelder and comprise approximately 85% and 10% of the trees respectively. There is no shrub or groundcover layer.

Manage the failure with engineering approaches and native vegetation reestablishment. Plant trees and shrubs in slope failure. Selectively cull the invasive species over multiple years and plant in the openings created by the culling. Seed with groundcover mix.

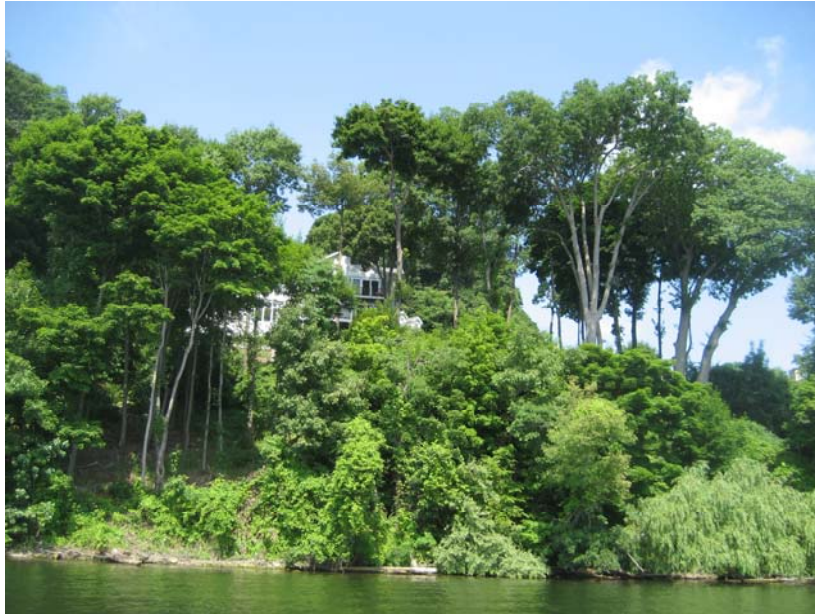
Prevention of disturbances is the most effective solution to preserving the native plant communities and helping maintain the stability of the slopes. The survey revealed there are various activities that are being completed by property owners including tree pruning and clearing, and dumping that are having an adverse impact on the slope vegetation. Some of this work is being completed by for hire tree and landscape companies. In some or perhaps many of these cases the

Photo 7. Understory vegetation was cleared and trees were pruned excessively on this slope, allowing non-native invasive Norway maple and ailanthus to become established.
